Innovation in wood

WEATHERING

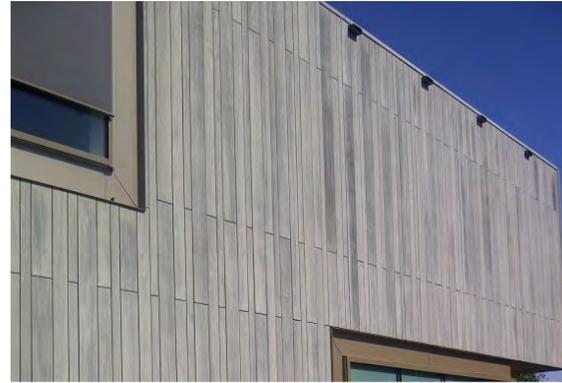
An example of such a blotchy transition period is shown in the image above (Dutch cladding project approximately a year after installation).

However, prior to turning grey, uncoated Accoya will go through a phase of bleaching where it turns a lighter shade of its normal colour. Surface growths are particularly apparent in this intervening period and can vary in level from board to board. This will become less distinguishable and objectionable after full (even) greying, but in this transition period the surface of Accoya may look blotchy.

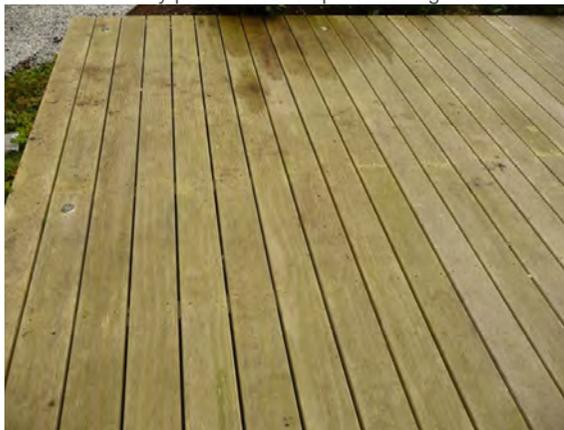
Shaded areas may promote development of algae.

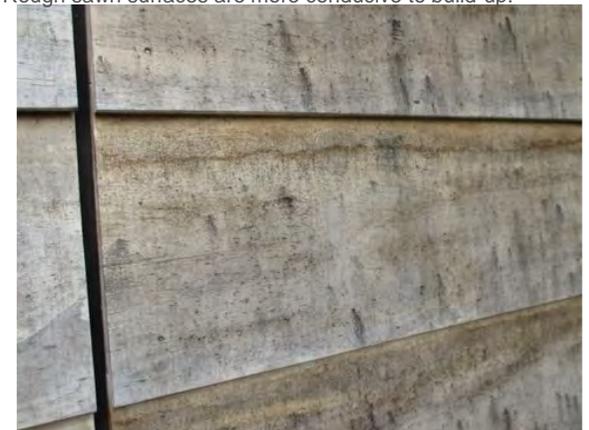
Rough sawn surfaces are more conducive to build-up.

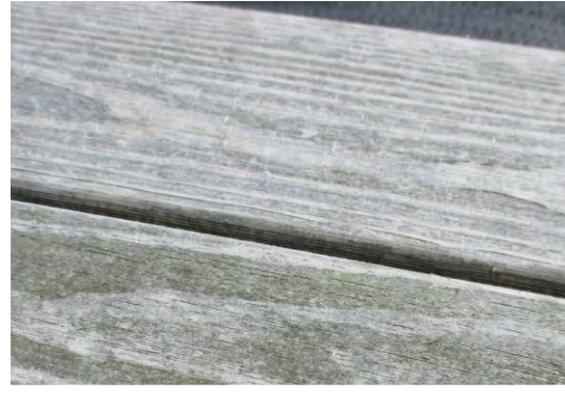
Natural occurring surface fibres on decking.

The higher the amount or intensity of UV the surface is subject to, the faster this process will de-velop. It should be noted that these fibres are formed on all exposed wood species, including Accoya, particularly on flat surfaces like decking. A ribbed deck profile will tend to cause an accumulation of these fibres, making it all the more noticeable.

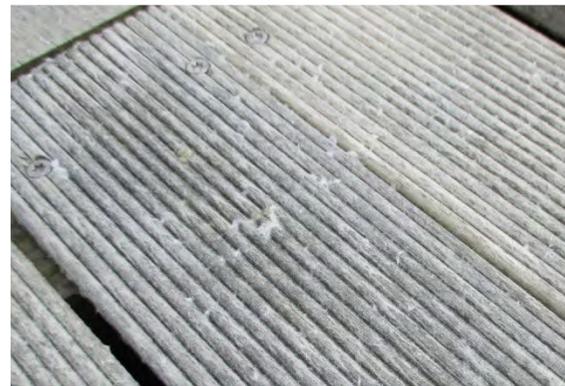
Fibres may get trapped in ribbed surface profiling.

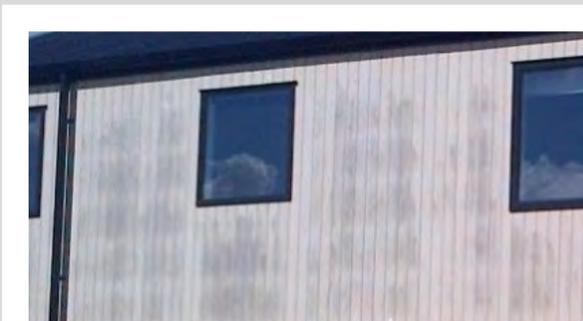
A New-Zealand housing project with a very distinct batten silhouette showing in the cladding surface.

Some projects have shown a distinct pattern reflecting the sub-frame behind the Accoya. This is caused by heat transferal from the building to the Accoya boards, which will decrease the average moisture content at the location of the interface.

Dryer conditions mean less mould growth, which is why the interfaces are clear where the rest of the board surface shows mould. Note that this effect can be observed on any façade with any kind of cladding or panelling material.

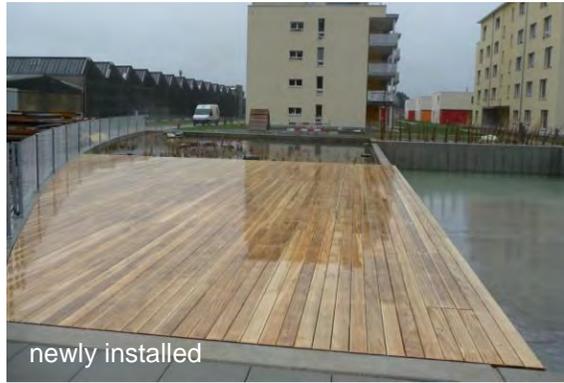
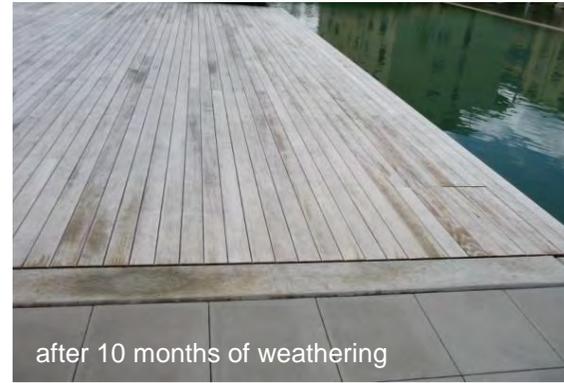
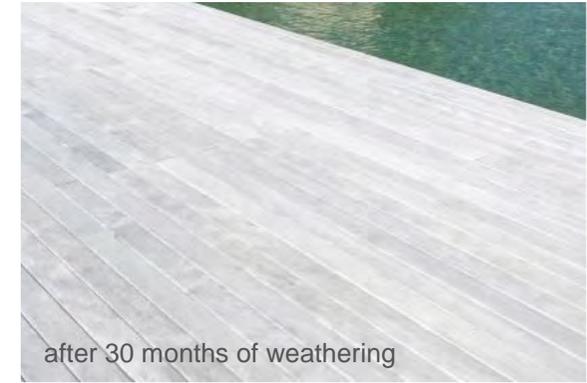
PUBLIC POOL DECKING, OESINGEN, SWITZERLAND.

This deck in Oesingen was photographed when newly installed (left), after 10 months (middle) and after 30 months of weathering (right).

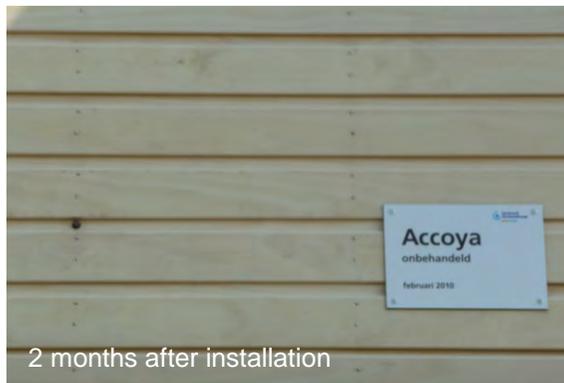
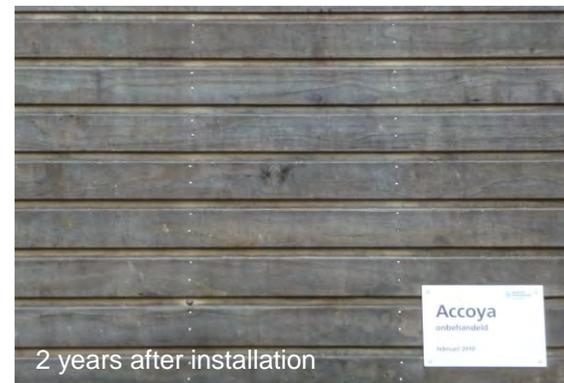
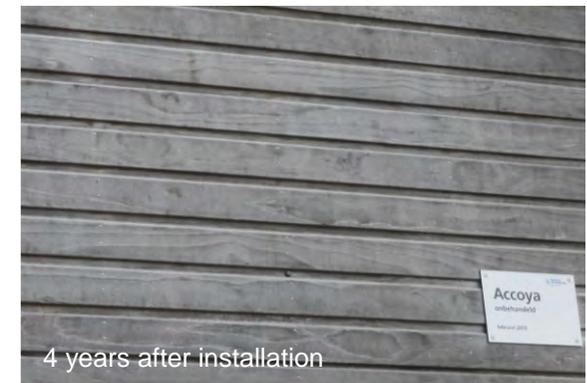
OFFICE CLADDING, VROOMS- HOOP, THE NETHERLANDS

A part of the South facing façade was cladded with Accoya in April 2010, with no maintenance since. The pictures below (left to right) show this cladding in July 2010, 2012 and 2014.

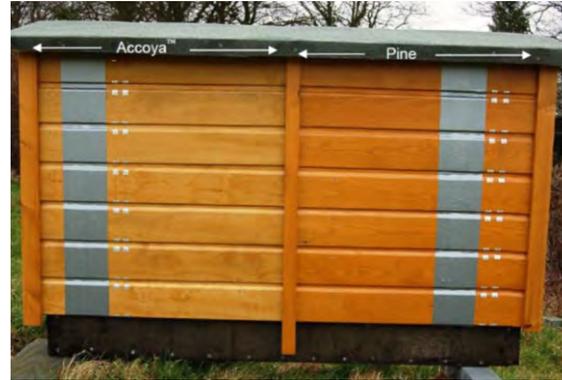
Test set-up at the start of the exposure in February 2008

A south-facing cladding rig was set up at BM Trada for the comparative performance evaluation of Accoya and unmodified pine coated with a semi-translucent stain.

The translucent stain system consisted of a pigmented primer with two topcoats. The cladding boards used were machined to a rebated shiplap profile with the upper edge rounded to a radius of $\pm 10\text{mm}$.

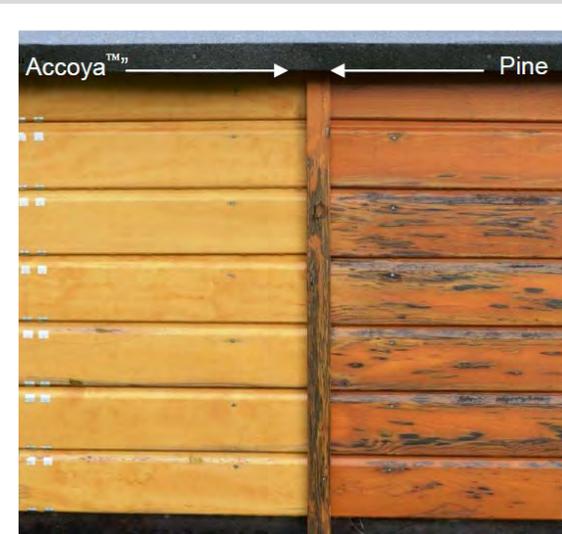
Test set-up after 7 years of exposure in January 2015

After nearly 7 years of south-facing exposure in a challenging environment the Accoya boards were found to be in a largely serviceable condition with only 2 of the 7 cladding boards showing discernible evidence of stress in the form of mould or mildew growth.

The pine boards were found to have developed severe blue-stain disfigurement leading to patchy and discontinuous disfigurement beneath the coating. The integrity of the coating on the pine boards was found to be severely compromised. Severe flaking and peeling of the coating had occurred not only along the rounded shoulder details but also on the flat faces where surface fissures and checking had occurred.
